2017 Chevrolet Volt

1G1RD6S59HU100179 • 140,218mi

Front Wheel Drive • 1.5L 4 Cylinder Engine • Gas/Elec (18.4 kWh) • A/T • Hard Top • Leather

1.3
AutoGrade
Rough

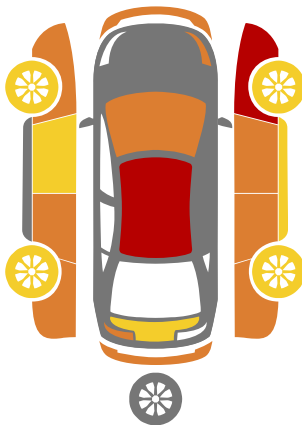
Condition Details

Description	Condition	Status	Image	Additional Info
● Windshield	Cracked			
● Grille Molding	Broken

Description	Condition	Status	Image	Additional Info
● Front Bumper Cover	Broken

● Roof	Oxidized			
● Right Drip Rail	Peeling			oxidation
● LF Door	Mult Dents/No Paint Dmg

● LF Fender	Mult Dents/No Paint Dmg

● LF Tire	Worn

● L Qtr Panel	Dent/Paint Dmg

● LR Door	Mult Dents/Paint Dmg

● LR Tail Lamp	Broken

● Rear Bumper Cover	Dent/Paint Dmg

● Deck Lid Emblem	Broken

● R Headlight	Broken

● R Qtr Panel	Heavy Mult Scratches

● R Qtr Panel	Mult Dents/No Paint Dmg

● R Rocker Panel Molding	Broken

● RF Door	Mult Dents/Paint Dmg

● RF Fender Liner	Broken

● RF Fender	Severe Damage
